DOE ACCIDENT PREVENTION AND INVESTIGATION

Bi-Annual Summary Report

U.S. Department of Energy ■ Office of Health, Safety and Security ■ AI-2011-01 ■ June 1, 2011

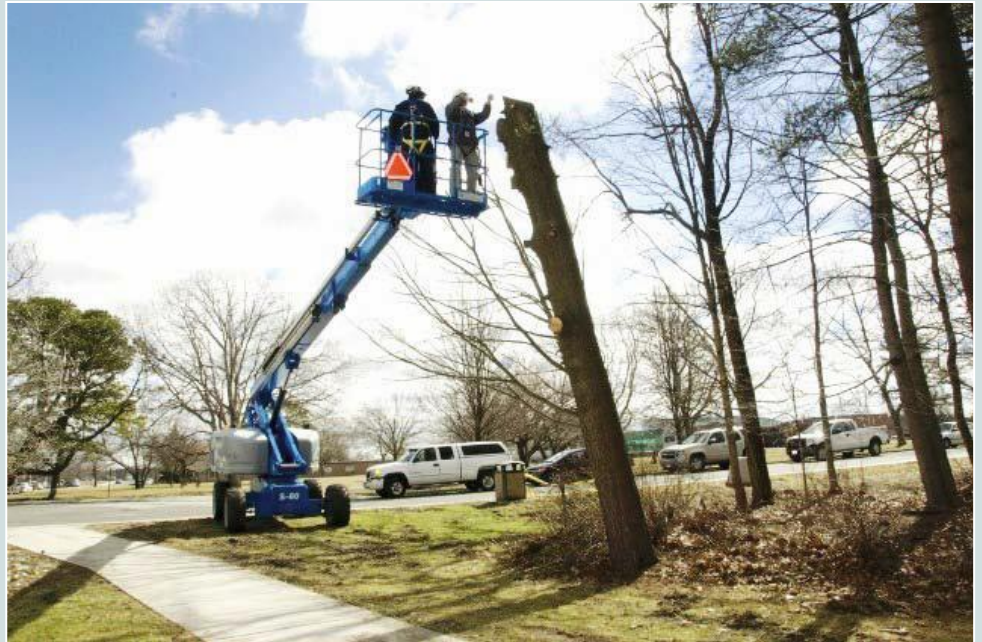
Building 488 Tree Felling Injury at
Brookhaven National Laboratory,
March 5, 2011

On Saturday, March 5, 2011 at approximately 10:20 a.m., a Brookhaven National Laboratory Building and Grounds Utility Worker was felling a pine tree while elevated in a 60-foot articulating and telescoping boom lift approximately 20-feet above the ground on the south side of Building 488. As the gas-powered, 20-inch chainsaw being used by the employee cut through the tree trunk, an approximately 8-foot long, 18-inch diameter, 520 pound section of tree trunk fell toward the aerial lift, striking the employee's right forearm, and compressing it against the top railing of the aerial lift basket.

The Accident Investigation Board concluded that this accident was preventable. The direct cause of this accident was the uncontrolled fall of the tree trunk section after it was cut loose from the pine tree. As best could be determined, the piece of trunk section struck the employee because the aerial lift basket was positioned at a place where gravity would cause the trunk section to fall. Though the trunk was leaning to the north/northeast (toward Building 488), it was believed that the employee expected the trunk section to fall away from the aerial lift basket after completing a downward angled (southeast to northwest) through-cut. However, as that cut was completed, gravity immediately allowed the already leaning trunk section to fall to the north/northeast and onto the employee.

The Accident Investigation Board identified two root causes: the Facilities and Operations Directorate(F&O) failed to conduct thorough hazard analyzes and implement effective work controls for protecting workers performing tree felling work; and the Facilities and Operations Directorate failed to ensure workers possessed needed skills to perform tree felling work, and have knowledge of industry work practices so as to recognize unsafe conditions. Three contributing causes were also identified: F&O failed to manage tree felling as greater than low ES&H risk work; F&O inadequately communicated management expectations on the use of a work permit for safely planning tree felling; and

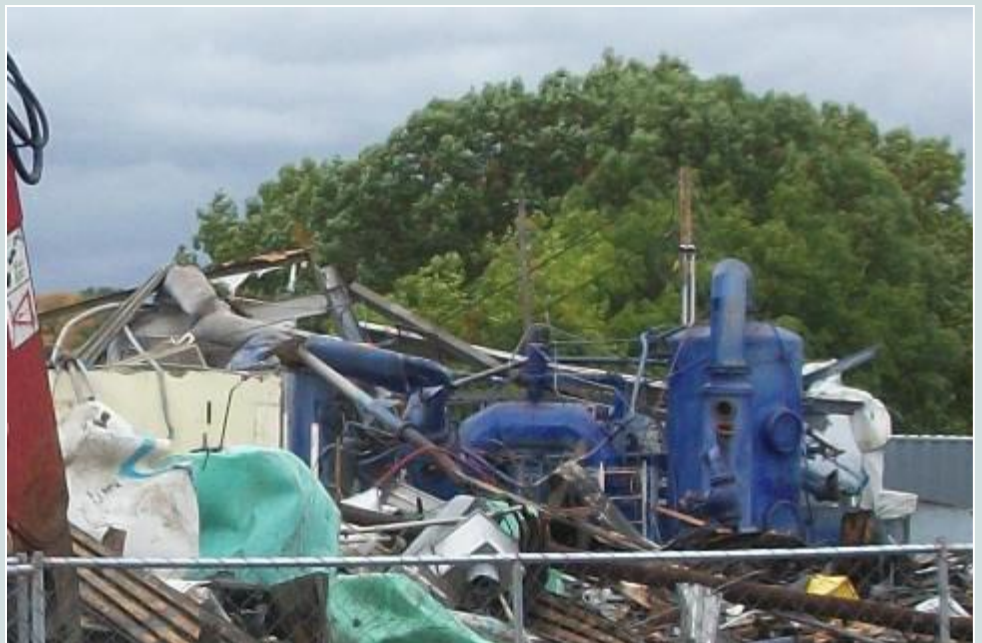
Radiological Contamination Event
During Separations Process Research
Unit Building H2 Demolition,
September 29, 2010

Accident Summary - On September 29, 2010, a radioactive contamination event occurred while performing open air demolition of Building H2 at the Separations Process Research Unit (SPRU) in Niskayuna, New York. Though initial indications demonstrated that low levels of contamination had been found on workers shoes and on KAPL property adjacent to the SPRU work activities, the magnitude and significance of the contamination event were not fully identified and understood by the SPRU project for several days. Based on the estimated cost to remediate the accident and event circumstances, a Type B investigation was ordered. On October 22, 2010, Mark Gilbertson, Deputy Assistant Secretary for Program and Site Support, U.S. Department of Energy, Office of Environmental Management (DOE-EM), formally appointed a Type B Accident Investigation Board to investigate the accident in accordance with DOE Order 225.1, Accident Investigations. The Board began the investigation on October 28, 2010, completed the investigation on November 11, 2010, and submitted findings to the Deputy Assistant Secretary for Program and Site Support on November 12, 2010.

By September 29, 2010, demolition of Building H2 had progressed to the point where the roof structure, the stack, and the exterior and interior walls with the exception of the north end above the 332' building elevation had been demolished and placed in intermodal containers for disposal. Demolition crews had removed an interior wall along the west half of the north end of the building the day before and were in the process of removing six evaporator system components that extended above and below the 332' elevation along the north-most outer wall. Following discussion in a 0800 morning meeting on September 29, 2010, the Cleveland Wrecking work group, with Washington Group International's (WGI) concurrence, proceeded to remove the following components from the north end of building footprint: evaporator condensers 221-A and 221-B, and columns 112-A, 112-B, and 113-B, which extended from the lower elevations of the building up above ground level, and size reduced condensers 221-A, 221-B, and column 113-B prior to identifying the spread of contamination event.

The Board identified the open air demolition of the evaporator system components as the direct cause of the accident.

- The failures by WGI to fully understand, characterize, and control the radiological hazard.
- The failure by WGI to implement a work control process that ensured facility conditions supported proceeding with the work.
